Invoice	19-121
File	CTI121 (BASELINE DEMO)
Date	9/16/2019

Coil String baseline demo

INSPECTION REPORT

Coiled Tubing baseline demo

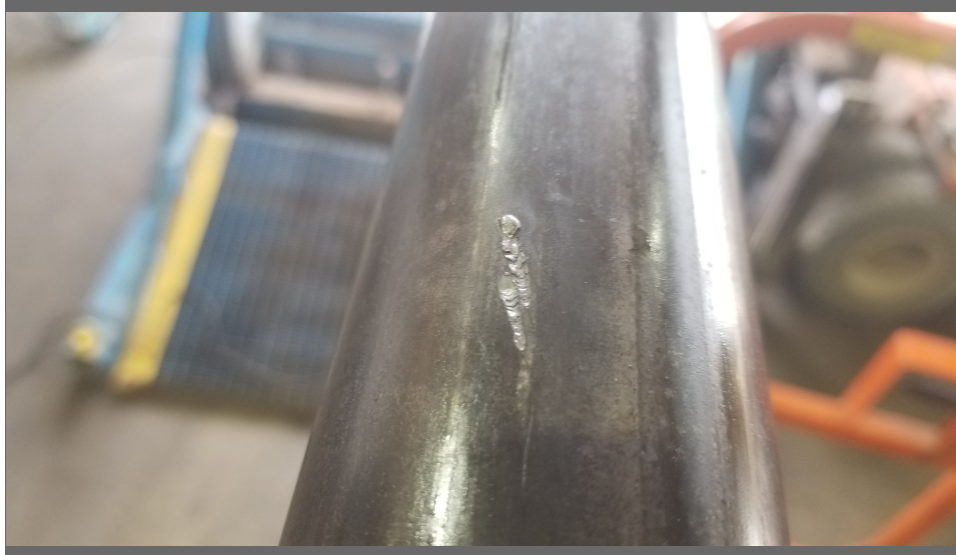
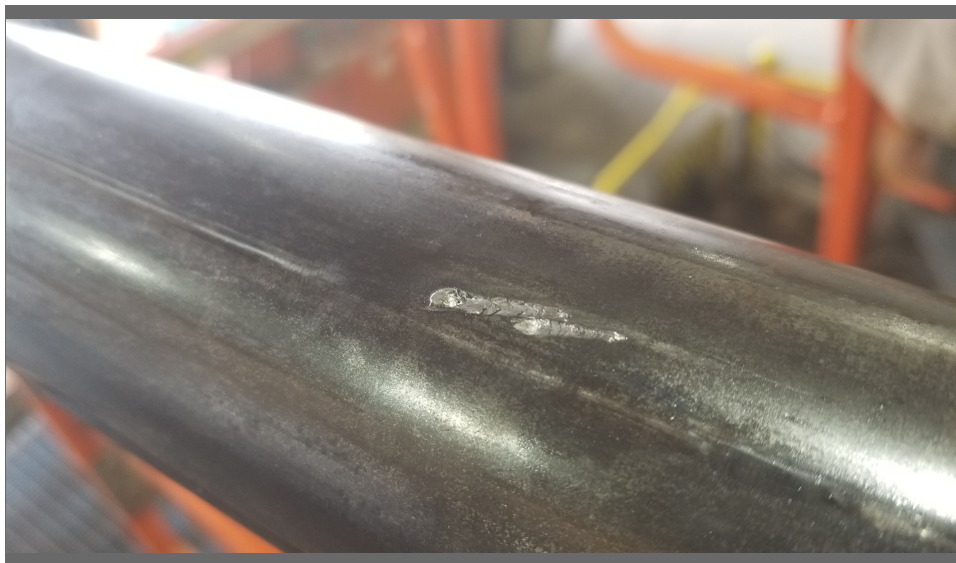
566m - 567m	OD (Max)	OD (Min)	Ovality	Pit Depth Gauge	UT (Max)	UT (Min)
Repaired	60.25mm (2.372")	60.04mm (2.364")	0.348%	0.012" or 0.305mm	5.32mm (0.209")	5.14mm (0.202")

External anomaly. This anomaly was repaired by Tenaris and measured before and after by CTI.

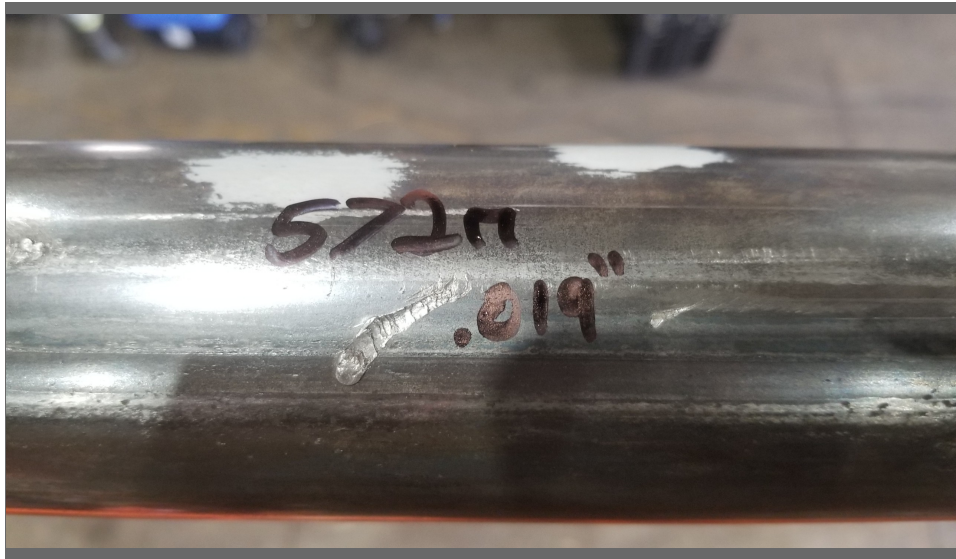
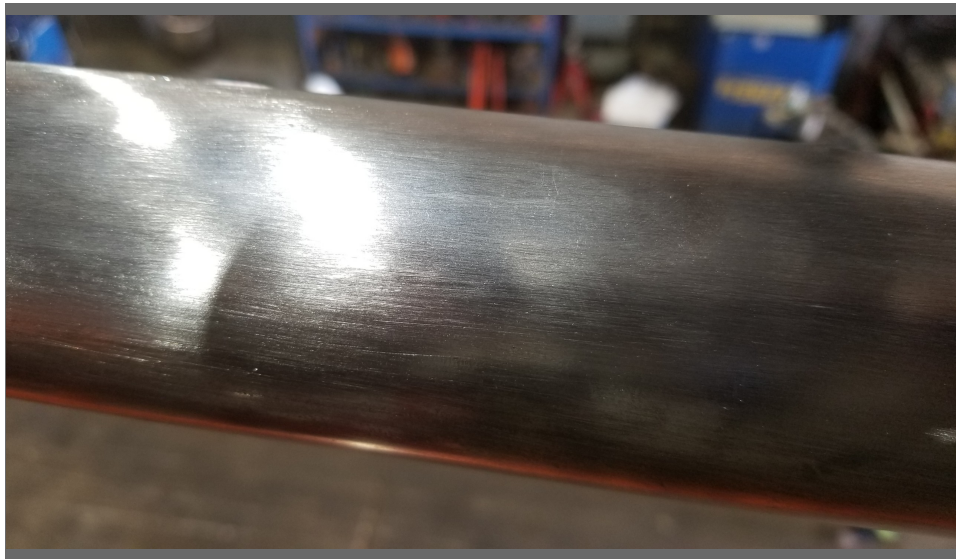
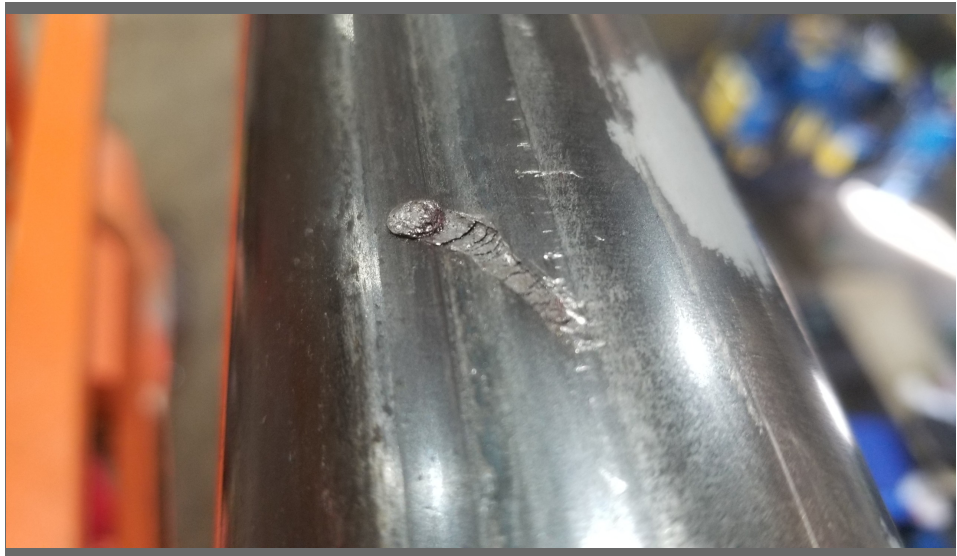
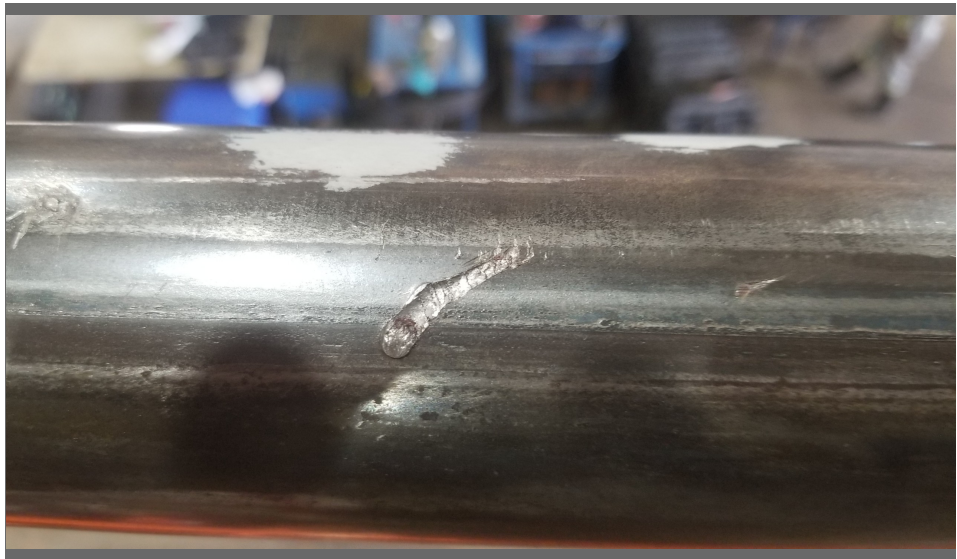
572m - 573m	OD (Max)	OD (Min)	Ovality	Pit Depth Gauge	UT (Max)	UT (Min)
Repaired	60.77mm (2.393")	60.09mm (2.366")	1.128%	0.019" or 0.483mm	5.32mm (0.209")	4.79mm (0.189")

External anomaly. This anomaly was repaired by Tenaris and measured before and after by CTI.

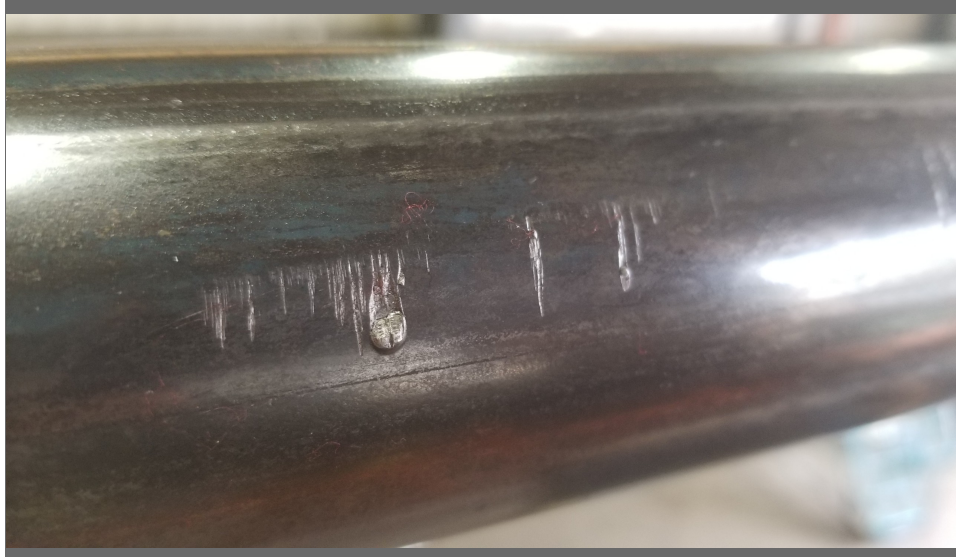
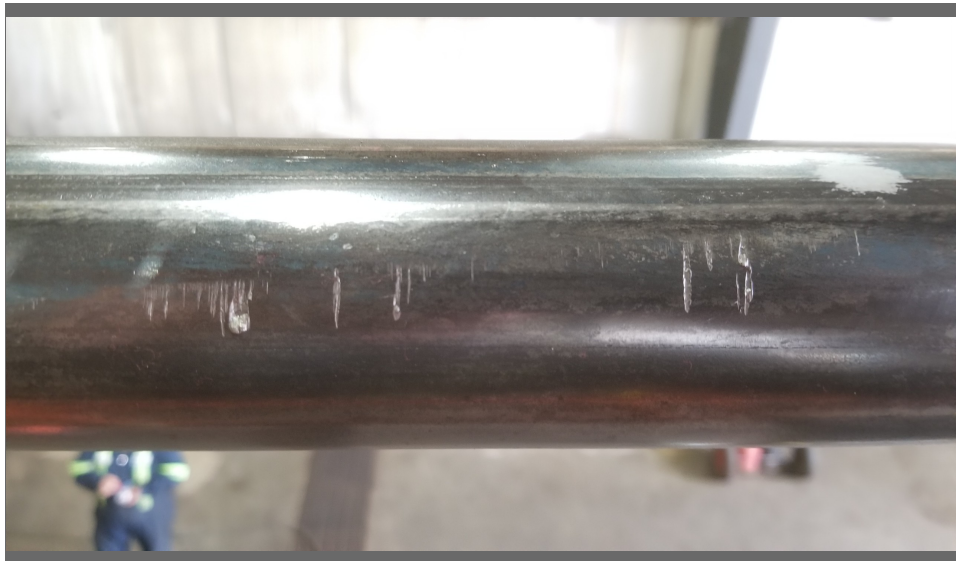
584m - 585m	OD (Max)	OD (Min)	Ovality	Pit Depth Gauge	UT (Max)	UT (Min)
Repaired	60.04mm (2.364")	59.51mm (2.343")	0.879%	0.018" or 0.457mm	5.29mm (0.208")	4.98mm (0.196")

External anomaly. This anomaly was repaired by Tenaris and measured before and after by CTI.

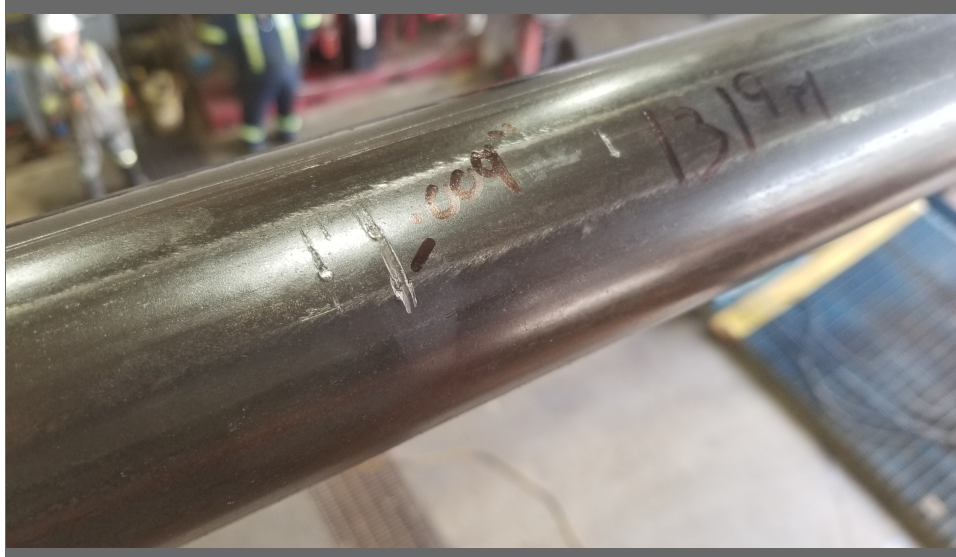
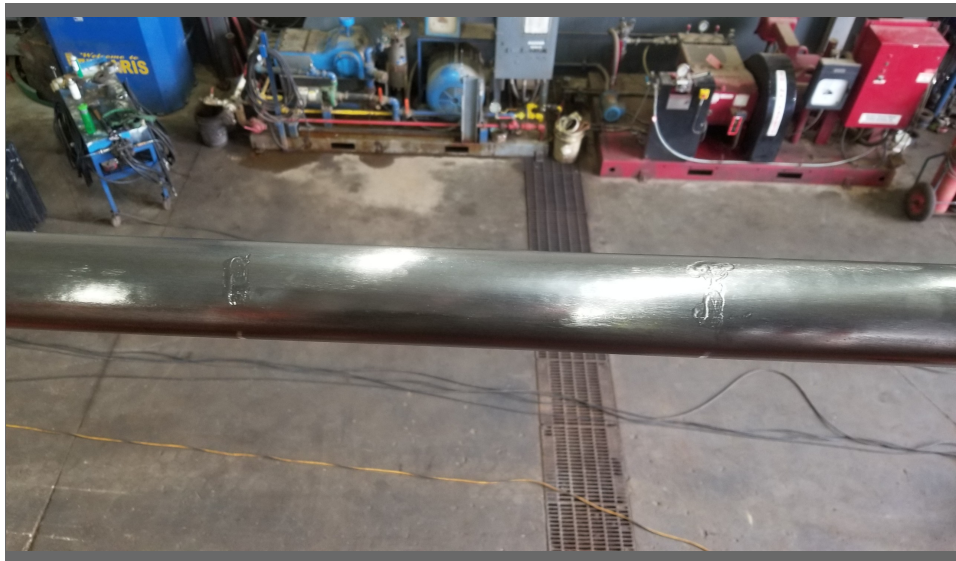
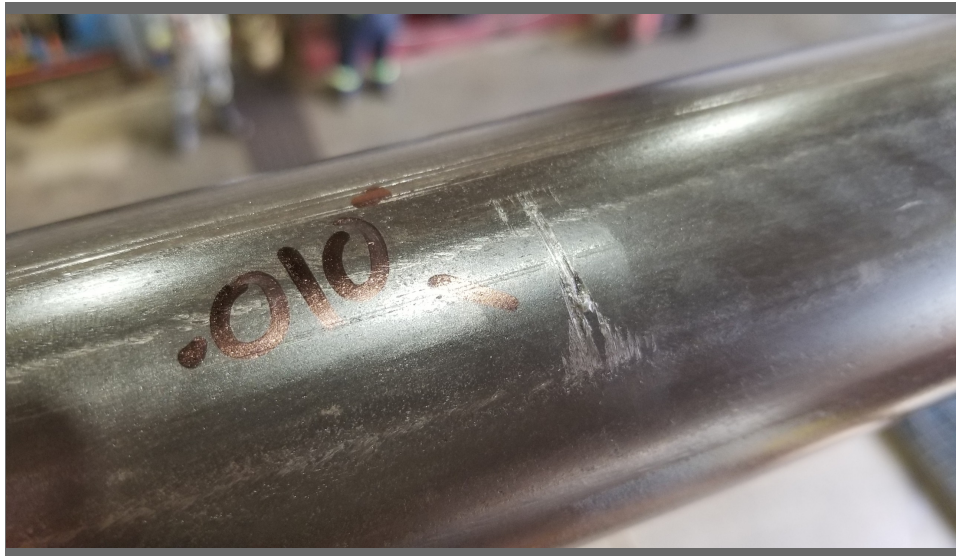
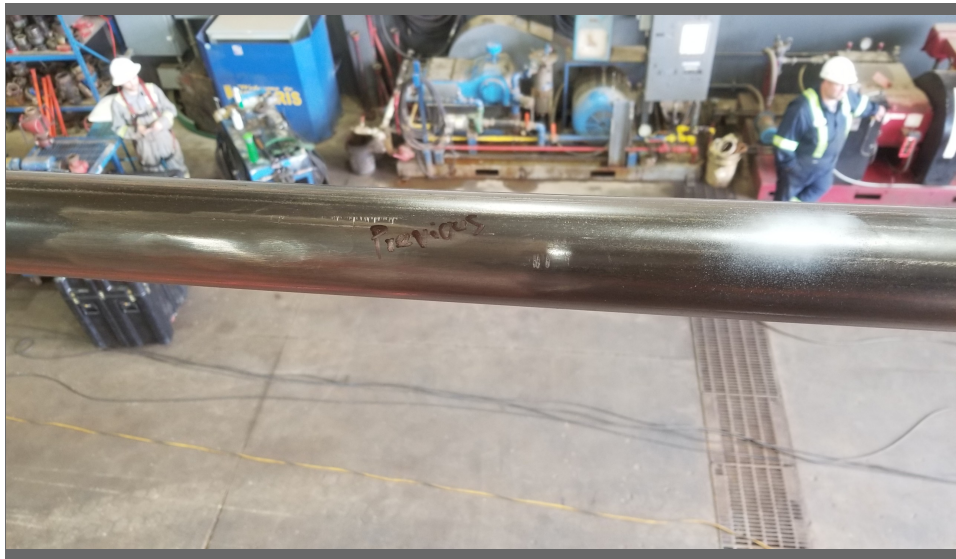
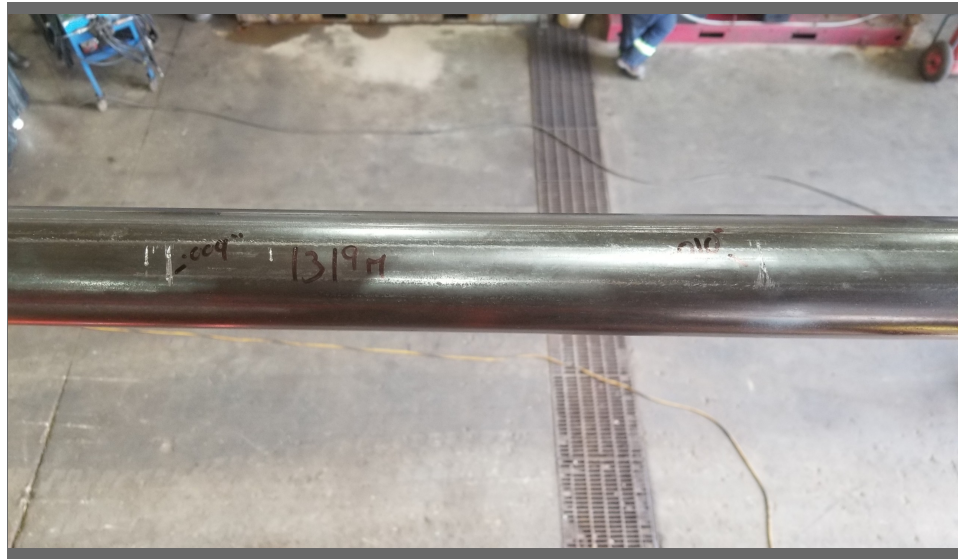
1,319m - 1,320m	OD (Max)	OD (Min)	Ovality	Pit Depth Gauge	UT (Max)	UT (Min)
Repaired	59.96mm (2.361")	59.76mm (2.353")	0.332%	0.010" or 0.254mm	5.30mm (0.209")	4.95mm (0.195")

External anomaly. This anomaly was repaired by Tenaris and measured before and after by CTI. Low UT reading on manufacturer repair of 4.95mm.

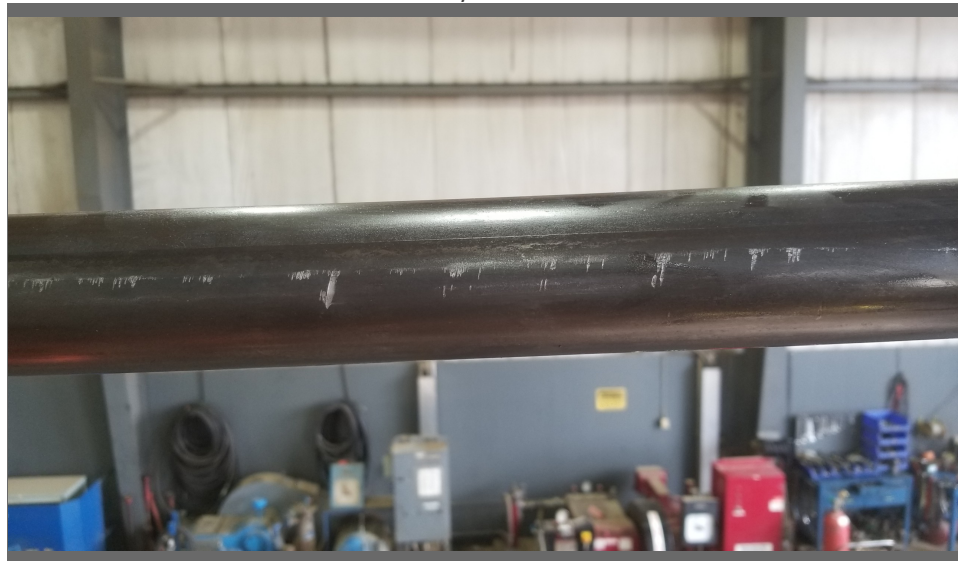
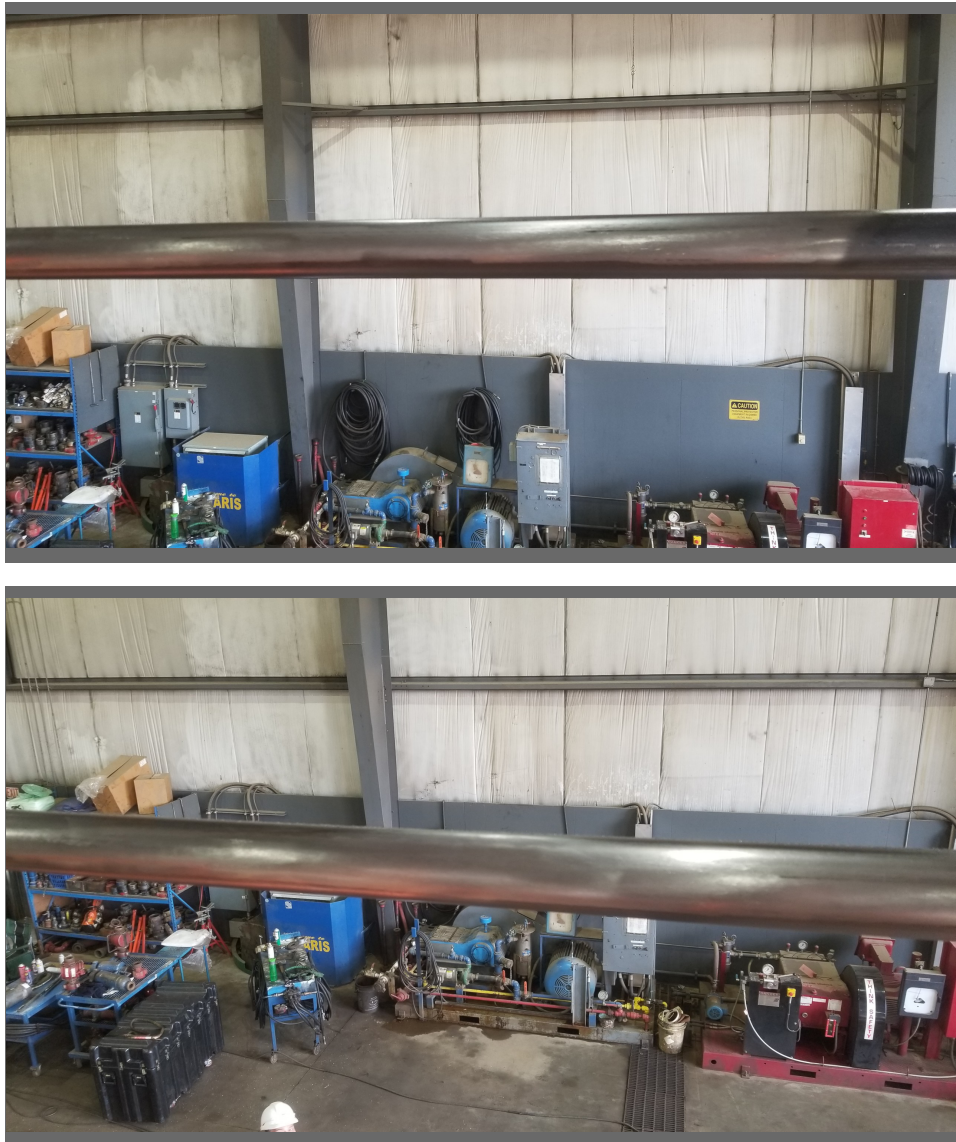
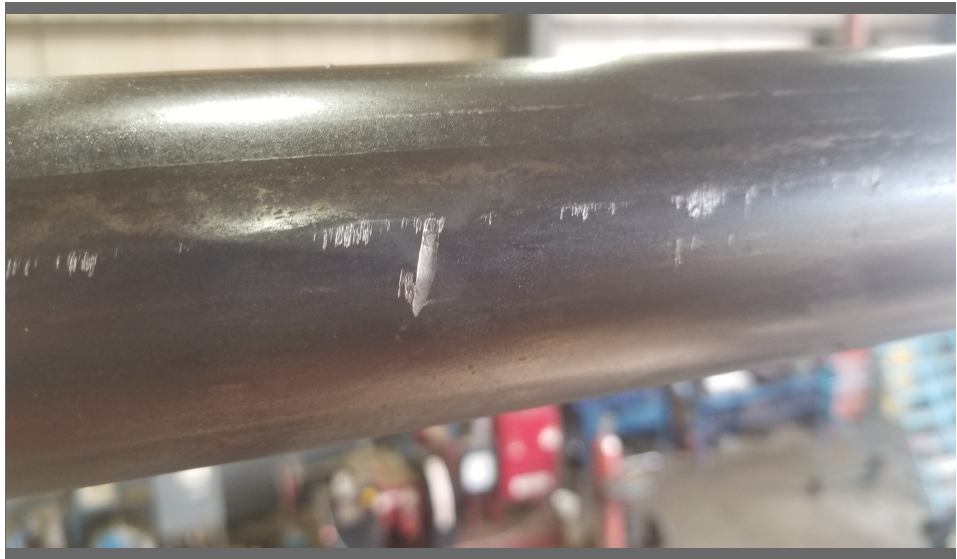
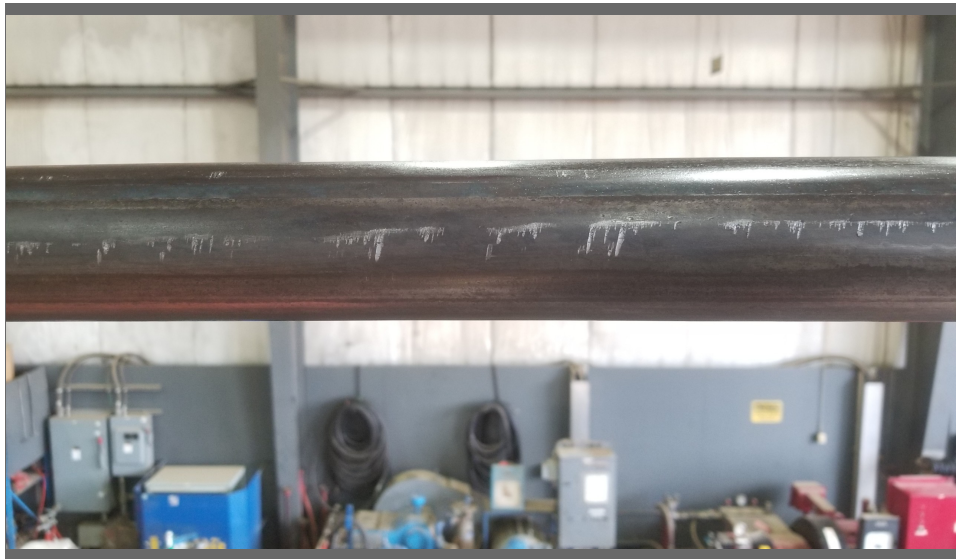
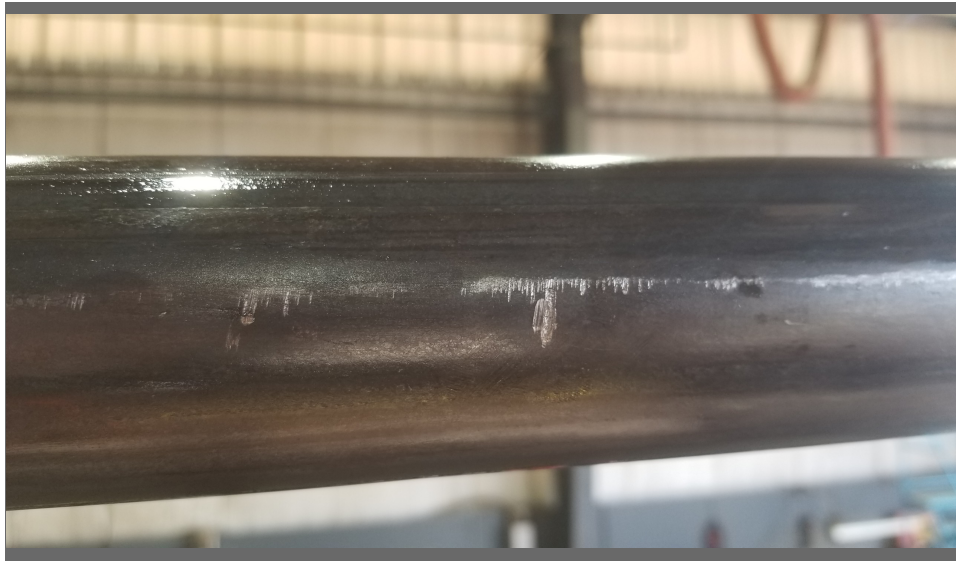
1,468m - 1,471m	OD (Max)	OD (Min)	Ovality	Pit gauge depth	UT (Max)	UT (Min)
Repaired	59.92mm (2.359")	59.67mm (2.349")	0.415%	.012" or .305mm	5.29mm (0.208")	5.14mm (0.202")

3m section of external anomalies on the left side of the CT. This area was repaired by Tenaris and measured before and after by CTI.

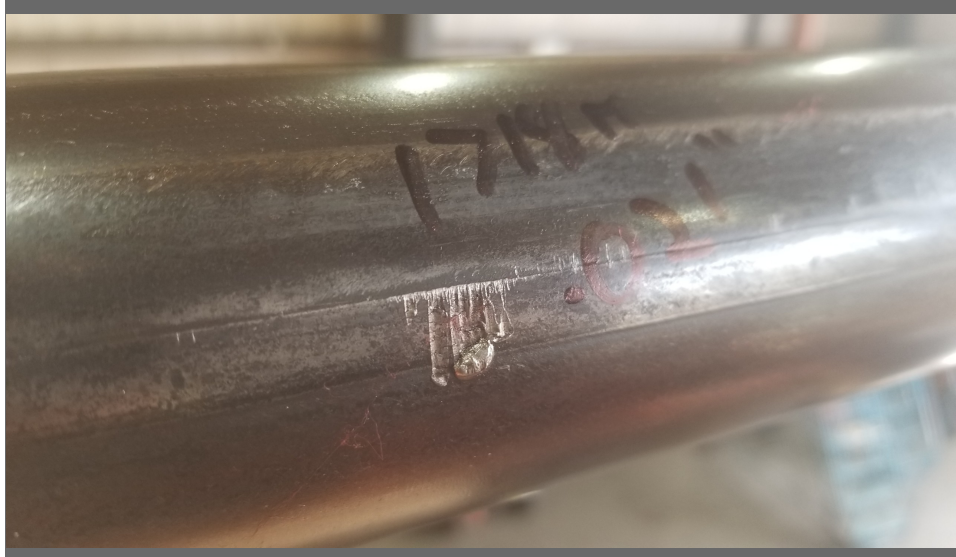
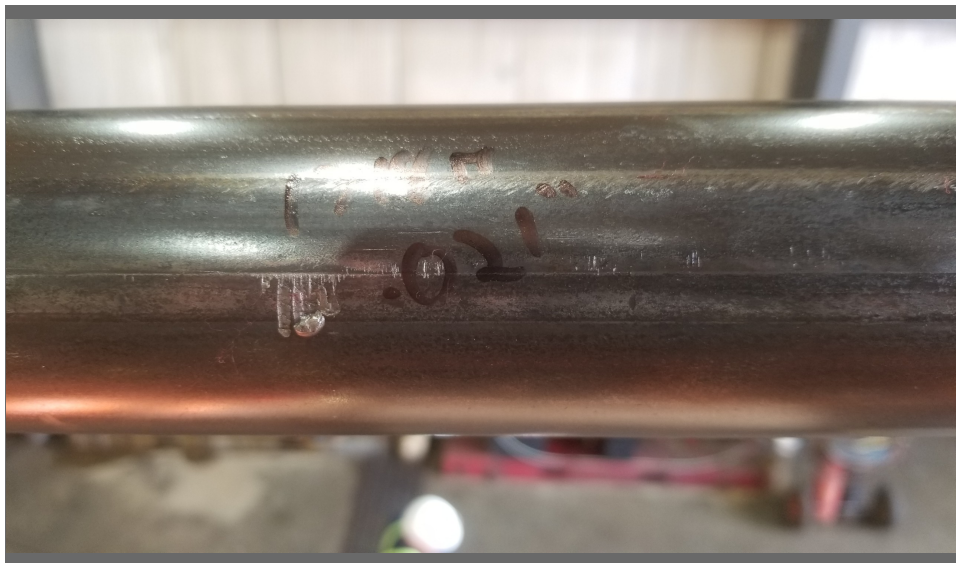
1,718m - 1,719m	OD (Max)	OD (Min)	Ovality	Pit Depth Gauge	UT (Max)	UT (Min)
Repaired	60.05mm (2.364")	59.51mm (2.343")	0.896%	0.021" or 0.533mm	5.50mm (0.217")	5.03mm (0.198")

External anomaly. This anomaly was repaired by Tenaris and measured before and after by CTI.

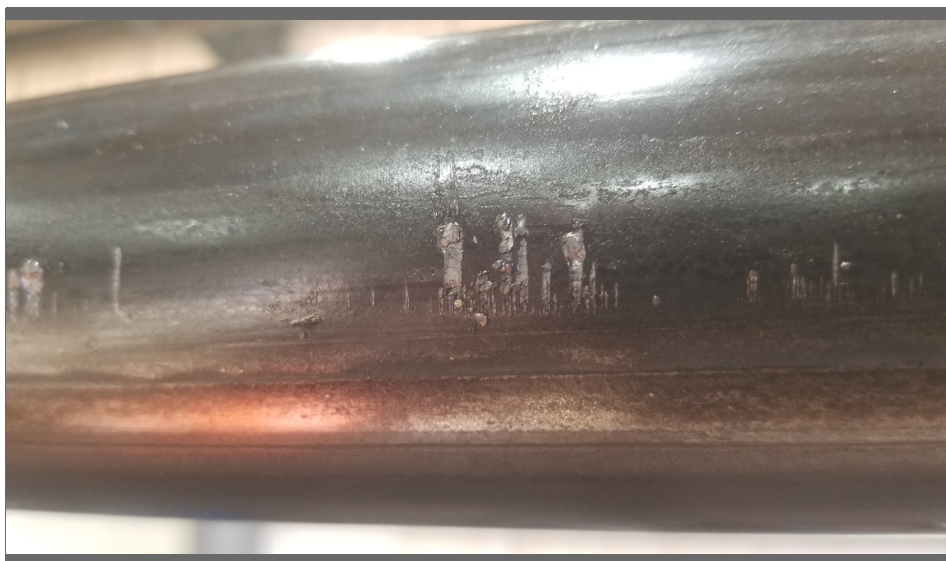
1,954m - 1,955m	OD (Max)	OD (Min)	Ovality	UT (Max)	UT (Min)
Comment	60.34mm (2.376")	60.01mm (2.363")	0.547%	5.33mm (0.210")	5.10mm (0.201")

Bias weld. External anomalies continue intermittently on the side of the tubing.

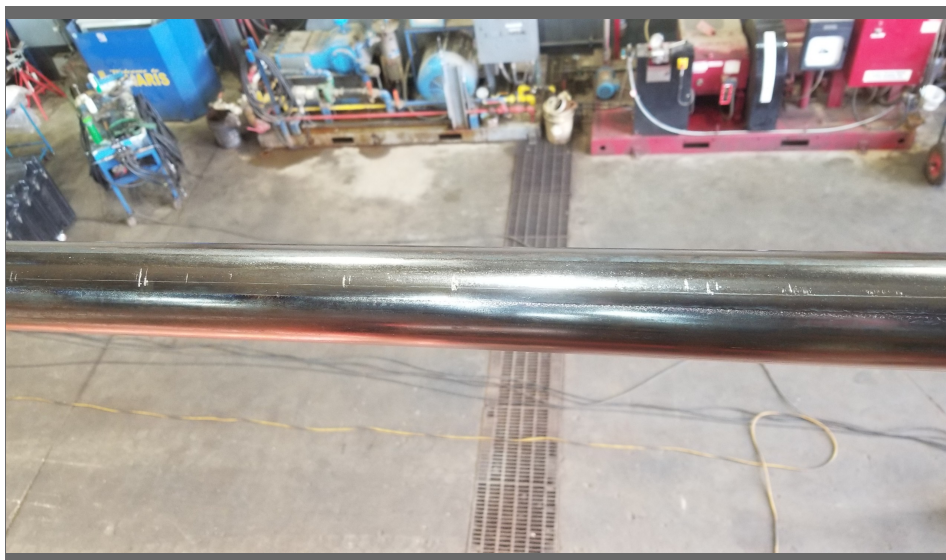
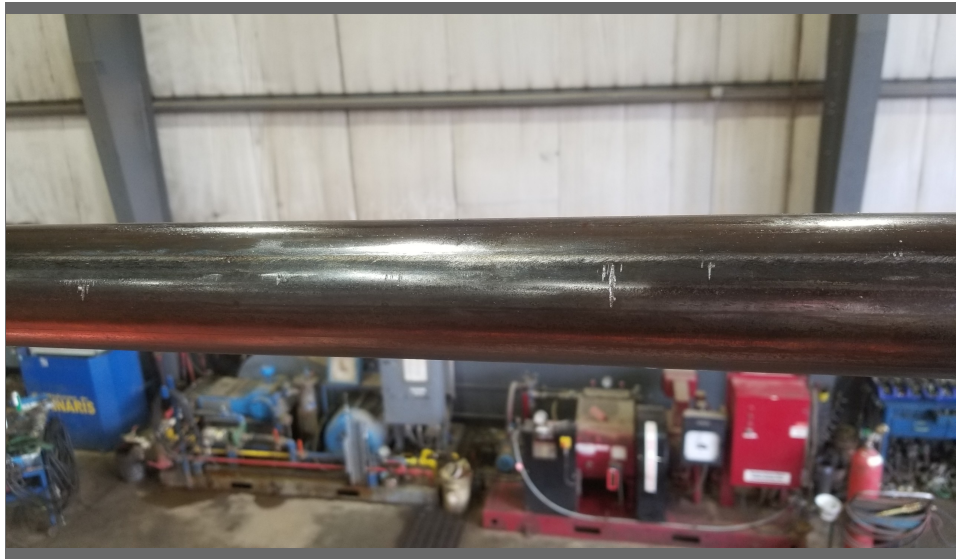
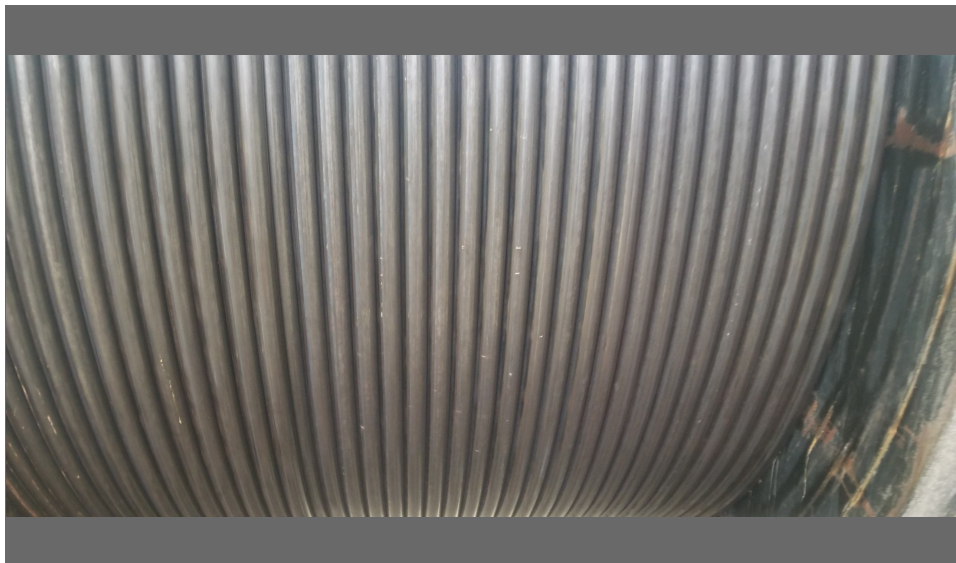
2,431m - 2,432m	OD (Max)	OD (Min)	Ovality	UT (Max)	UT (Min)
Comment	60.39mm (2.378")	60.09mm (2.366")	0.498%	5.31mm (0.209")	5.19mm (0.204")

Bias weld. Anomalies continue toward tail.

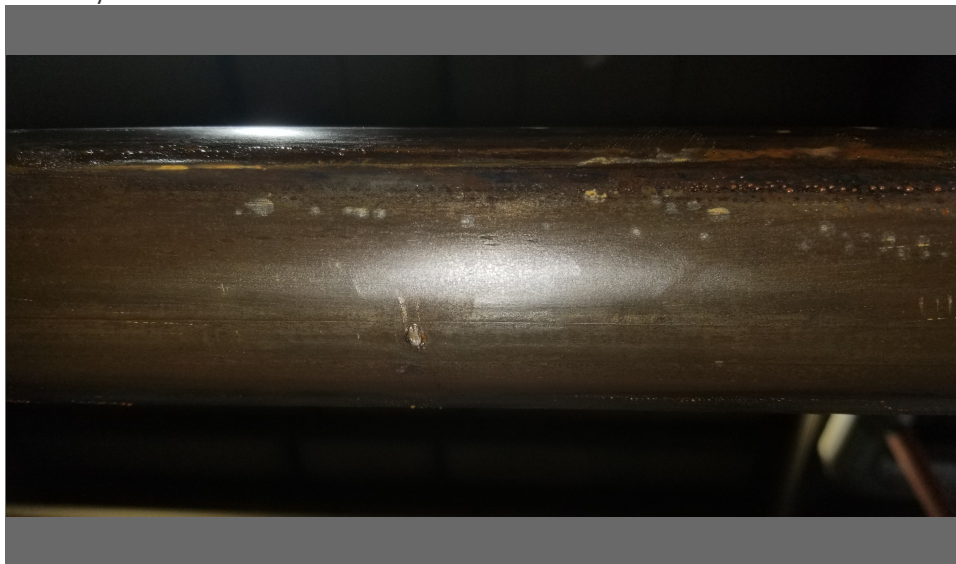
2,473m - 2,474m	OD (Max)	OD (Min)	Ovality	UT (Max)	UT (Min)
-----------------	----------	----------	---------	----------	----------

Raised metal external anomaly. Raised metal was repaired by CTI exposing a 0.006" anomaly.

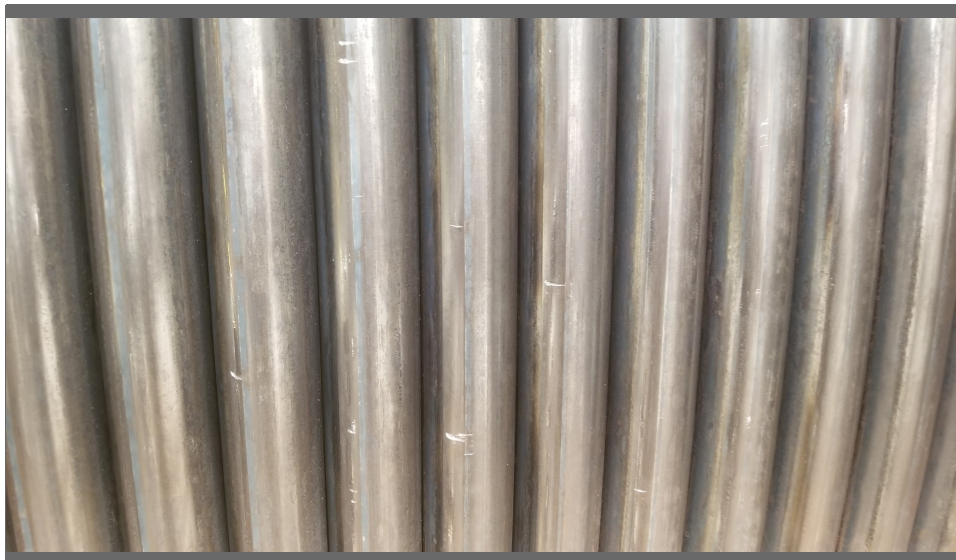
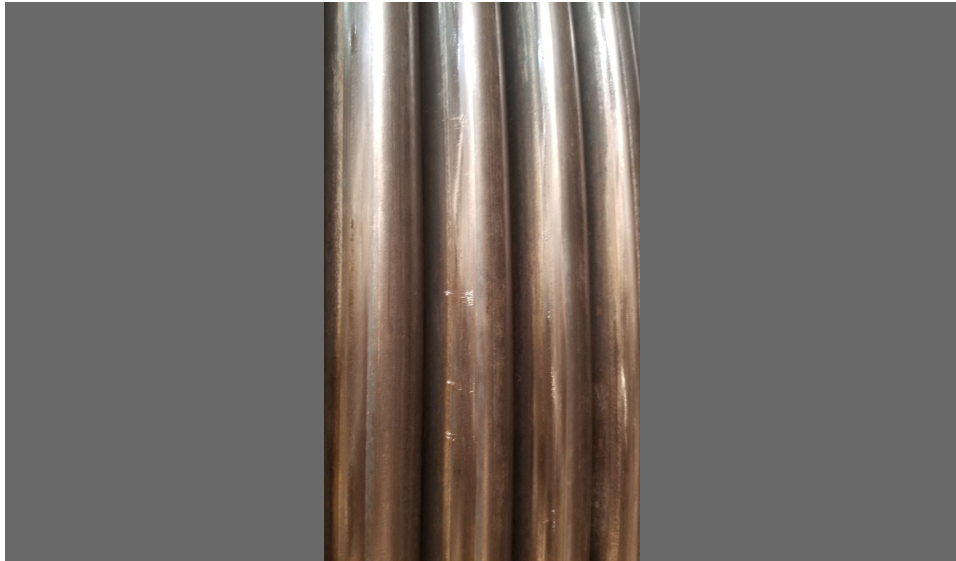
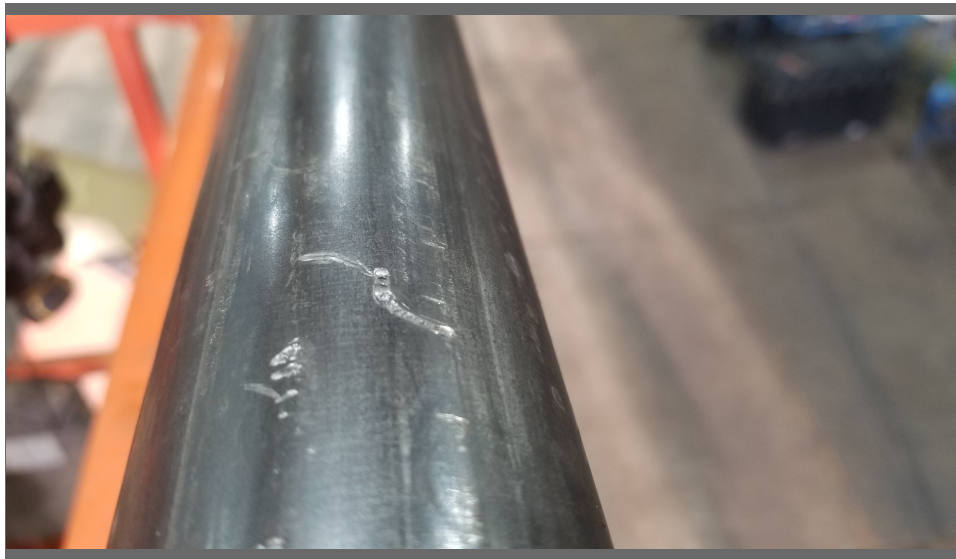
2,906m - 2,907m	OD (Max)	OD (Min)	Ovality	UT (Max)	UT (Min)
-----------------	----------	----------	---------	----------	----------

Bias weld.

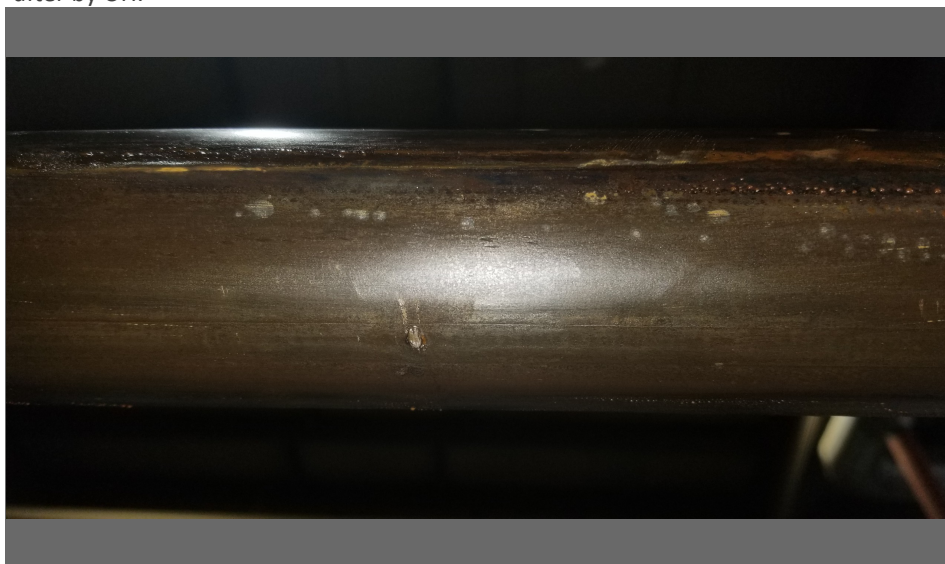
3,331m - 3,332m	OD (Max)	OD (Min)	Ovality	Pit Depth Gauge	UT (Max)	UT (Min)
Repaired	60.26mm (2.372")	59.97mm (2.361")	0.481%	0.015" or	5.22mm (0.206")	4.90mm (0.193")

External anomaly. This anomaly was repaired by Tenaris and measured before and after by CTI.

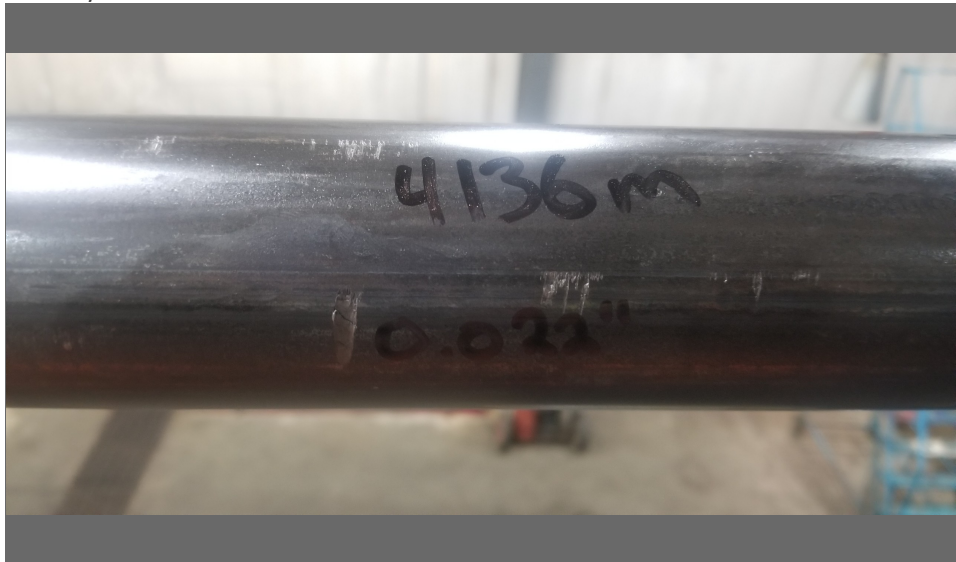
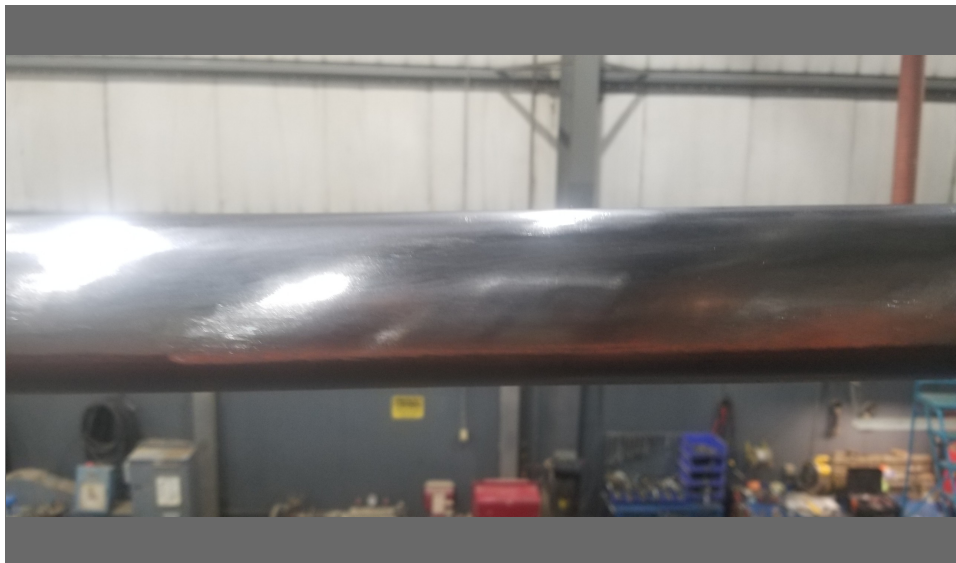
4,136m - 4,137m	OD (Max)	OD (Min)	Pit Depth Gauge	UT (Max)	UT (Min)
Repaired	60.57mm (2.385")	60.09mm (2.366")	0.022" or 0.559mm	4.54mm (0.179")	4.03mm (0.159")

External anomaly. This anomaly was repaired by Tenaris and measured before and after by CTI.

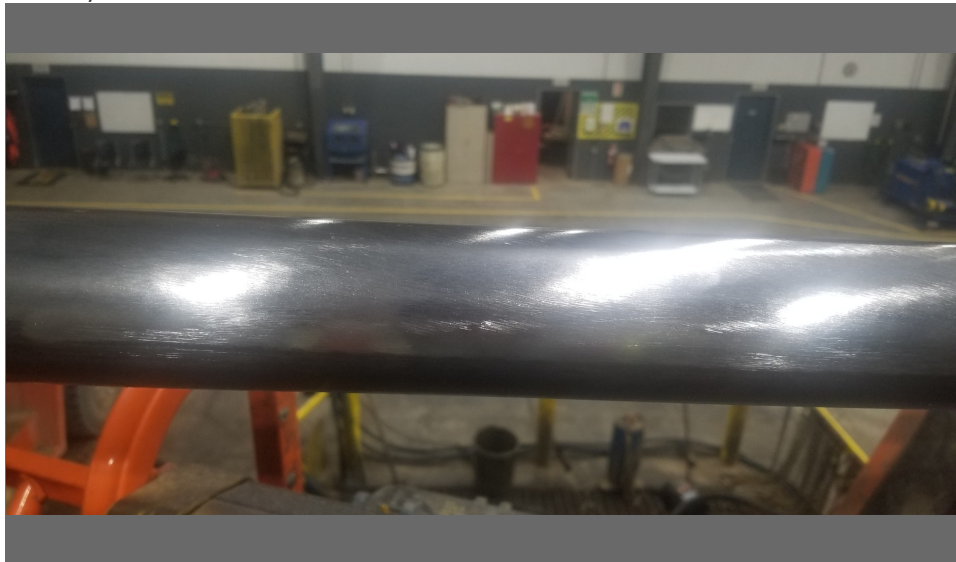
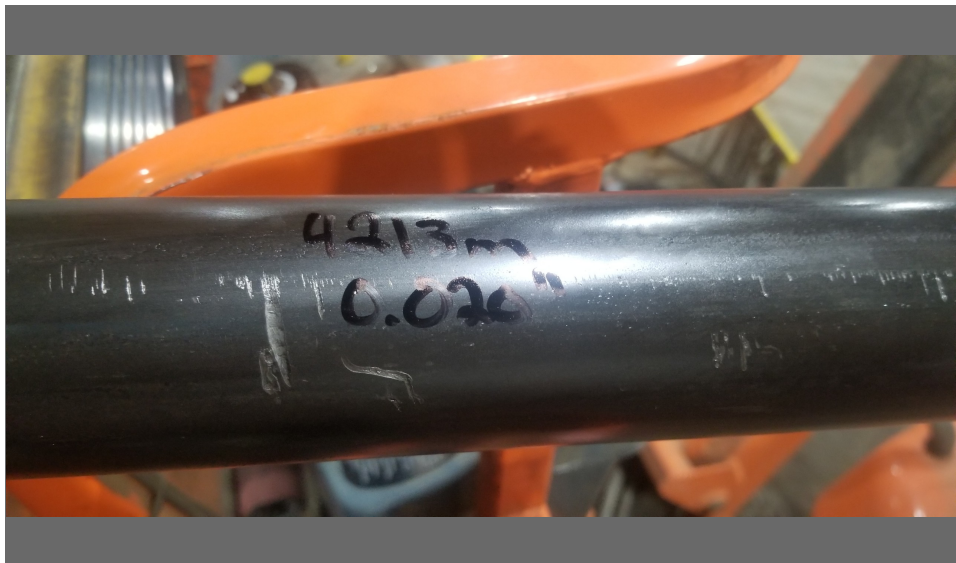
4,213m - 4,214m	OD (Max)	OD (Min)	Ovality	Pit Depth Gauge	UT (Max)	UT (Min)
Repaired	60.34mm (2.376")	59.99mm (2.362")	0.580%	0.020" or 0.508mm	4.60mm (0.181")	4.16mm (0.164")

External anomaly. This anomaly was repaired by Tenaris and measured before and after by CTI.

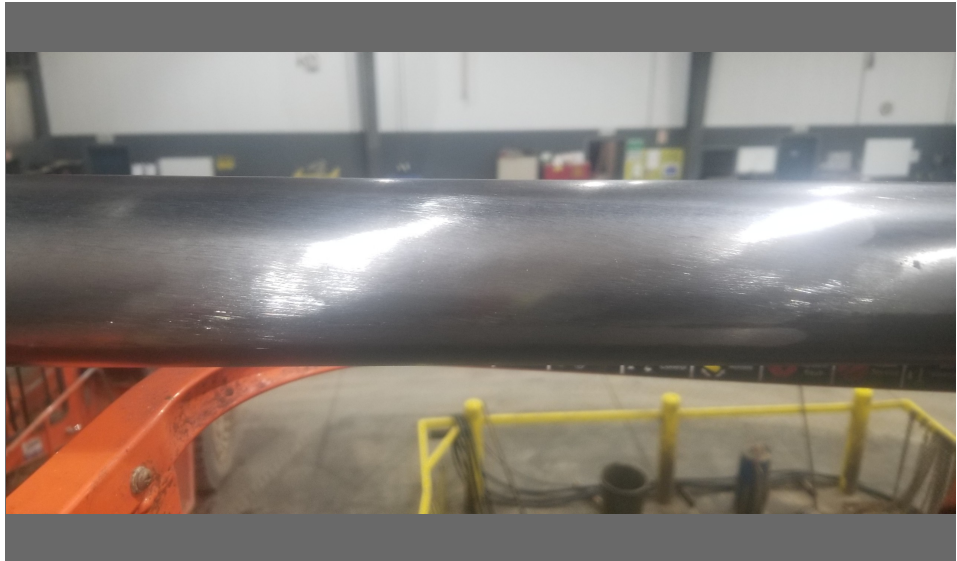
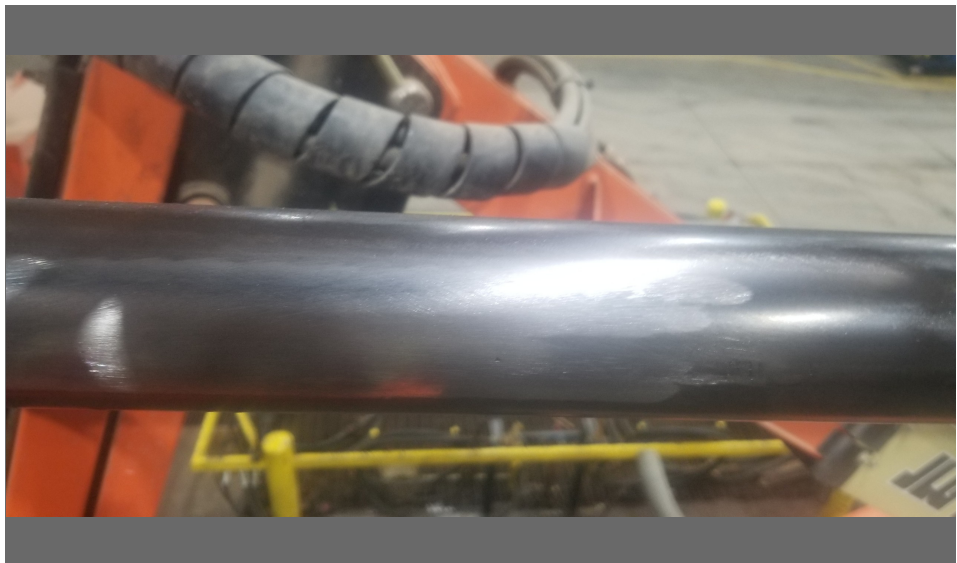
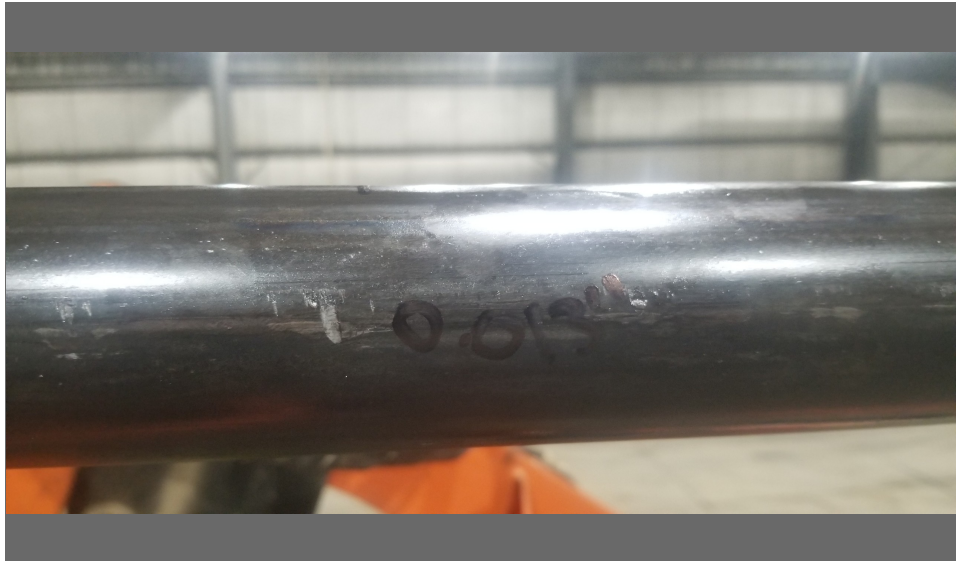
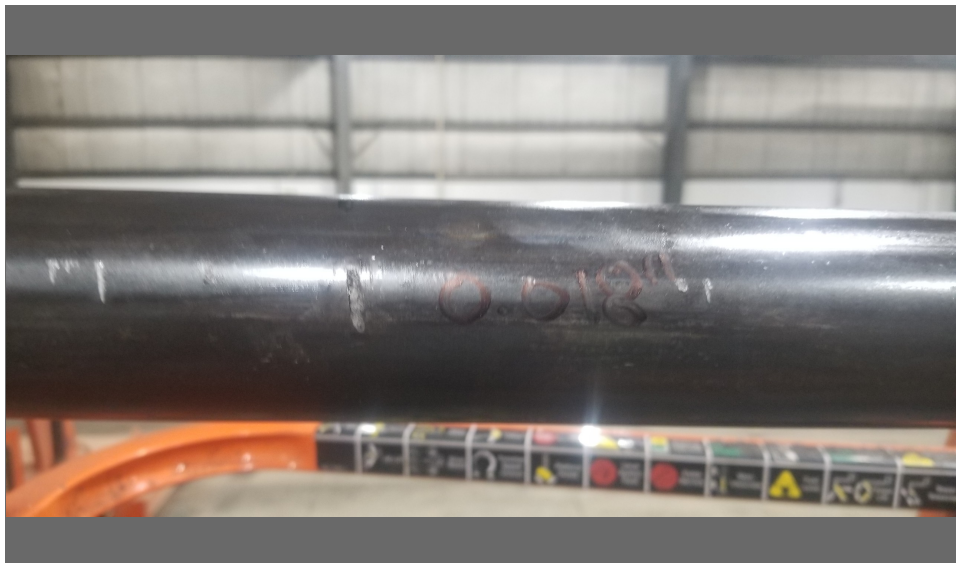
4,255m - 4,256m	OD (Max)	OD (Min)	Ovality	Pit Depth Gauge	UT (Max)	UT (Min)
Repaired	60.65mm (2.388")	60.29mm (2.374")	0.597%	0.018" or 0.457mm	4.56mm (0.180")	4.13mm (0.163")

Two external anomalies in the area. These anomalies were repaired by Tenaris and measured before and after by CTI.

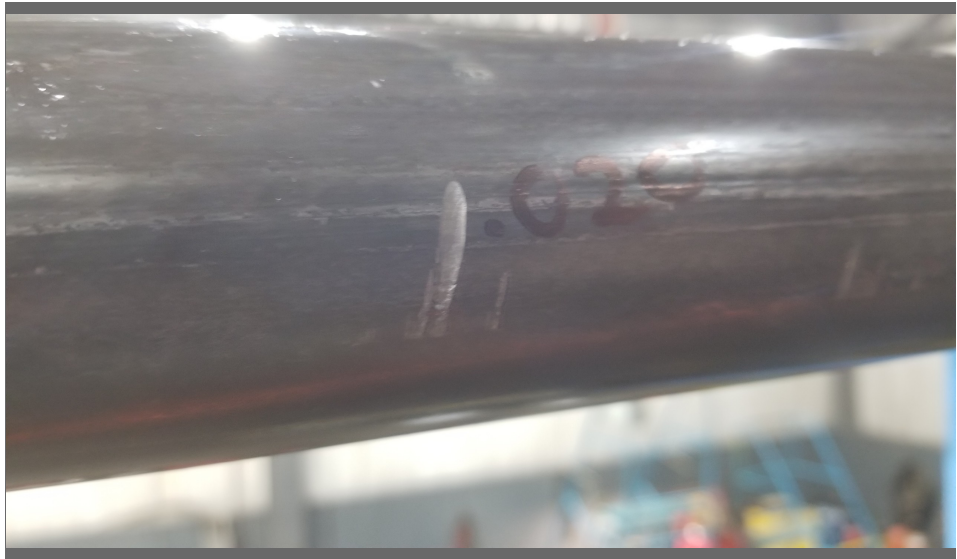
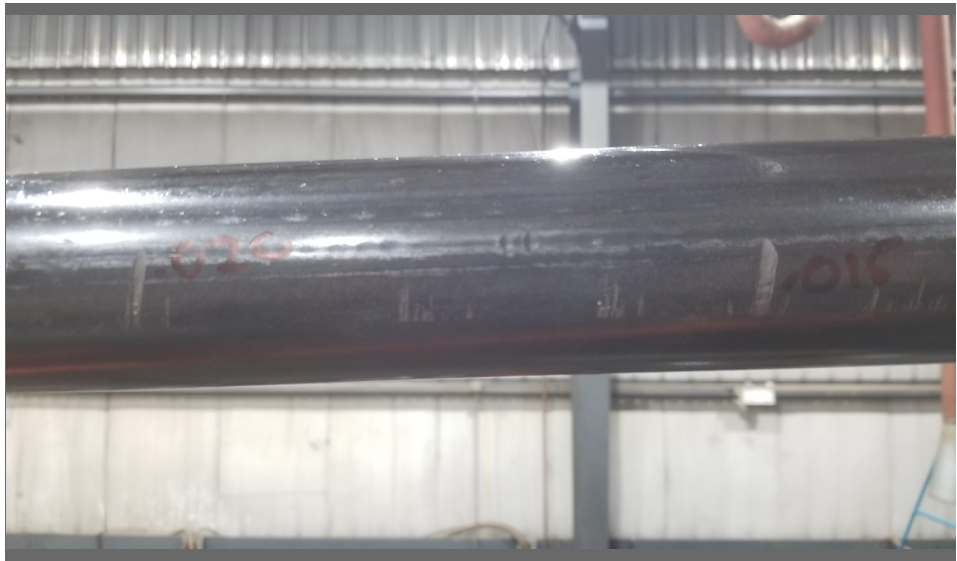
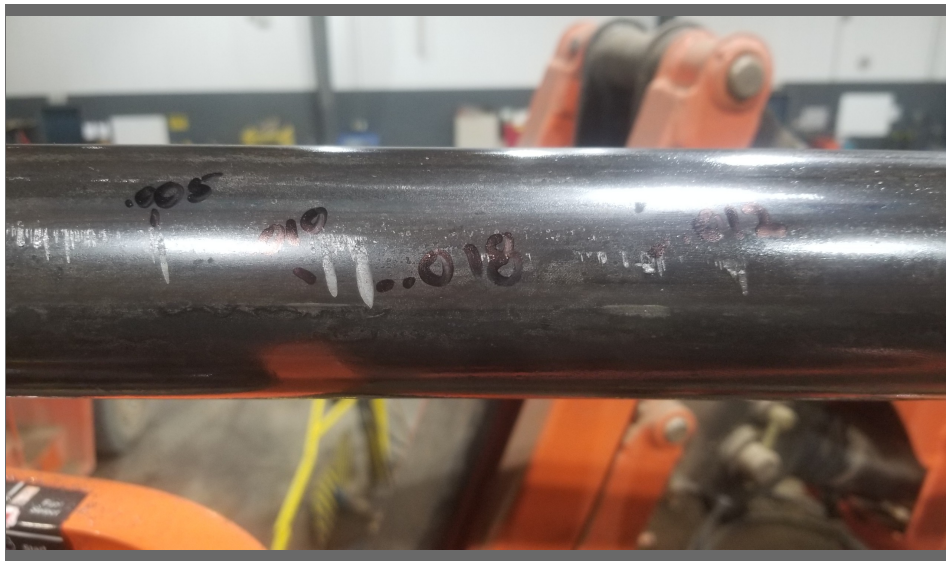
4,261m - 4,262m	OD (Max)	OD (Min)	Ovality	Pit Depth Gauge	UT (Max)	UT (Min)
Repaired	60.70mm (2.390")	60.04mm (2.364")	1.095%	0.020" or 0.508mm	4.58mm (0.180")	4.22mm (0.166")
Four external anomalies in the area. These anomalies were repaired by Tenaris and measured before and after by CTI.
