Invoice	19-121
File	CTI121 (BASELINE DEMO)
Date	9/16/2019

Coil String baseline demo

INSPECTION REPORT

Coiled Tubing baseline demo

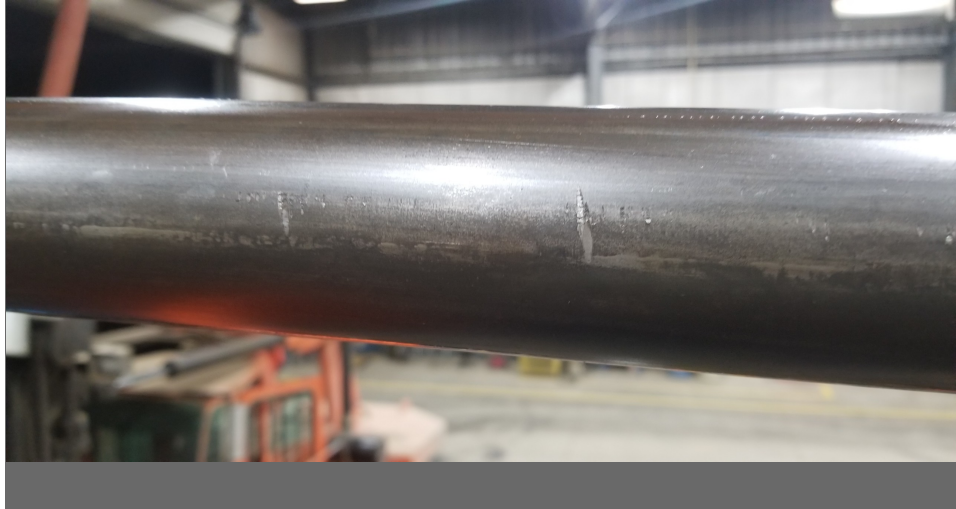
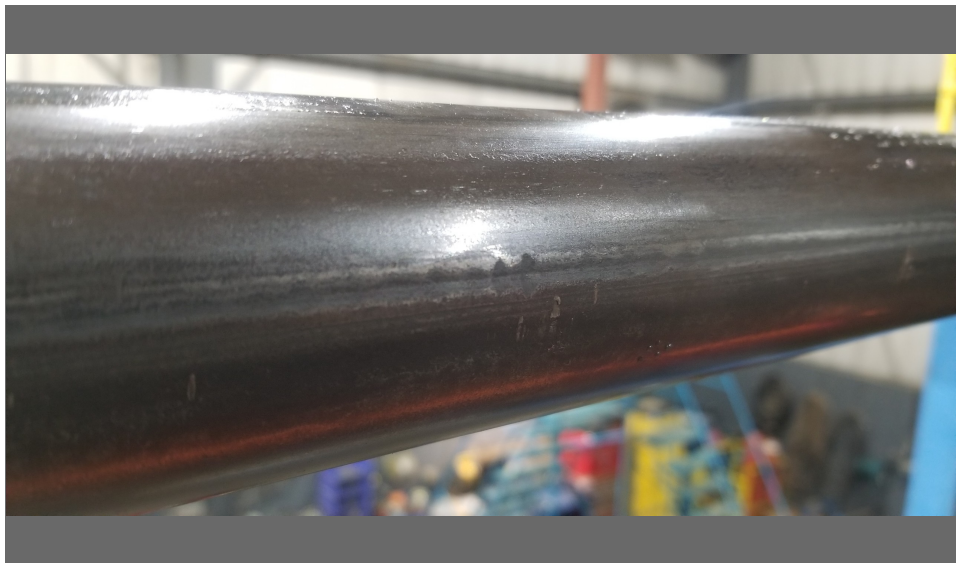
4,583m - 4,584m	OD (Max)	OD (Min)	Ovality	UT (Max)	UT (Min)
Caution	60.87mm (2.396")	59.86mm (2.357")	1.675%	4.57mm (0.180")	4.48mm (0.176")
External anomaly. Indentations along seam of tubing.

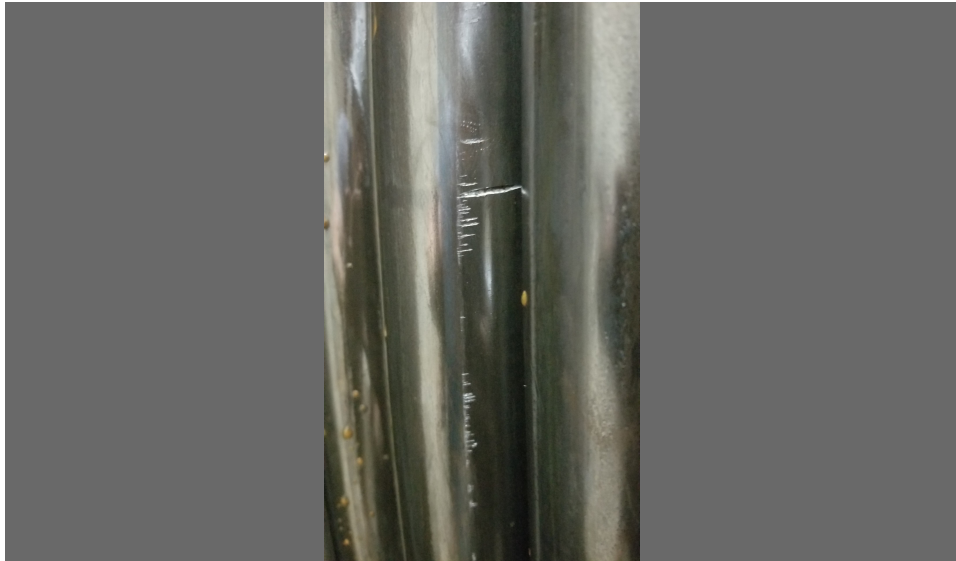
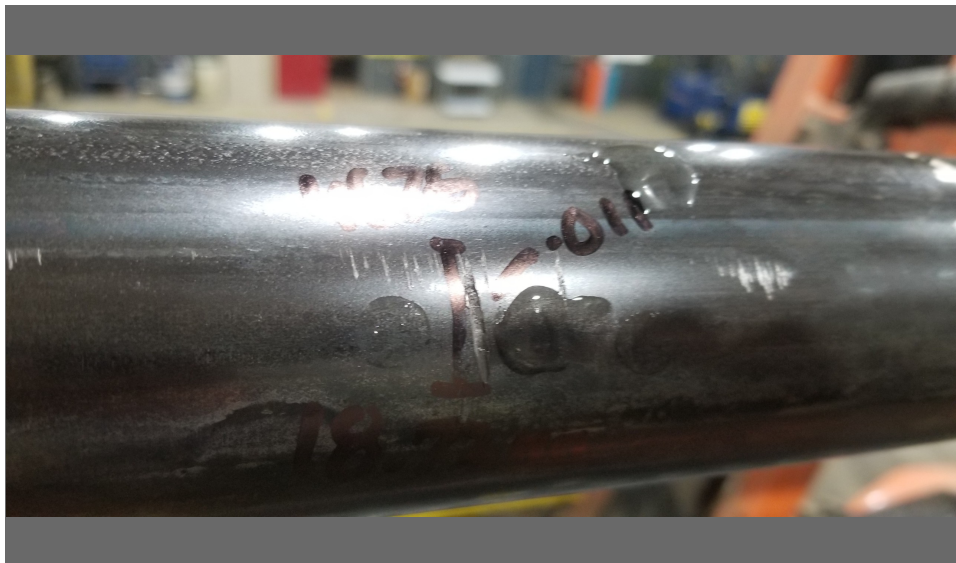
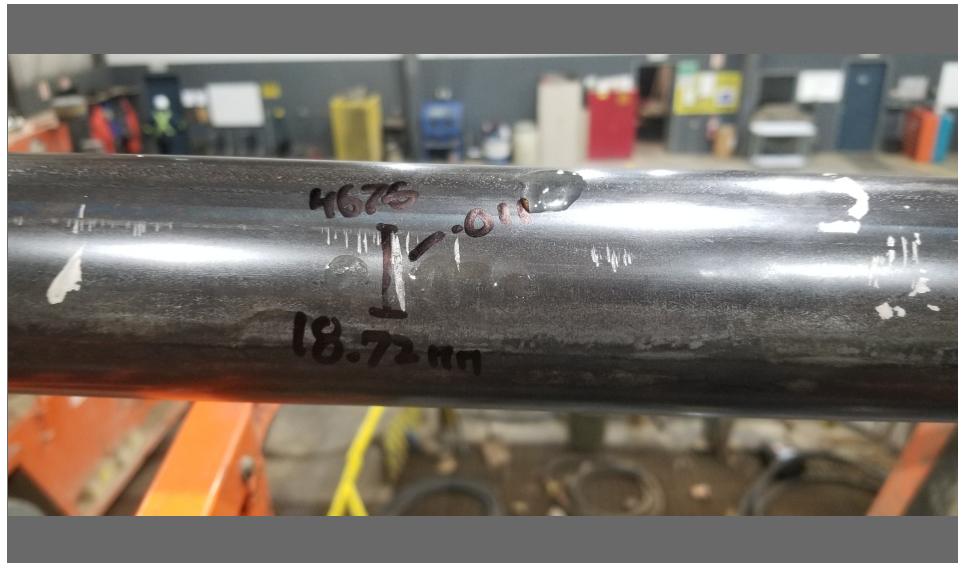
4,676m - 4,677m	OD (Max)	OD (Min)	Ovality	Pit Depth Gauge	UT (Max)	UT (Min)
Caution	60.63mm (2.387")	60.33mm (2.375")	0.498%	0.011" or 0.279mm	4.62mm (0.182")	4.34mm (0.171")
External anomaly.

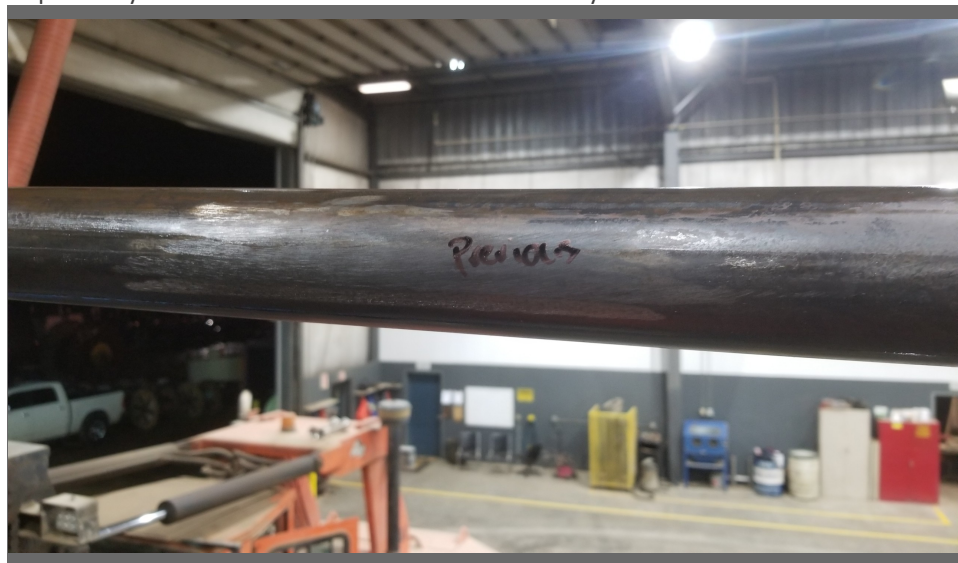
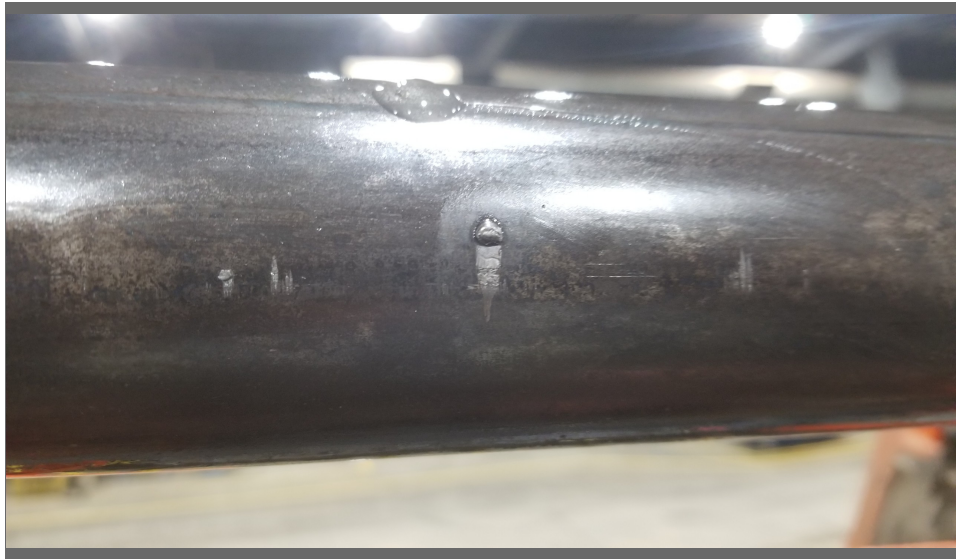
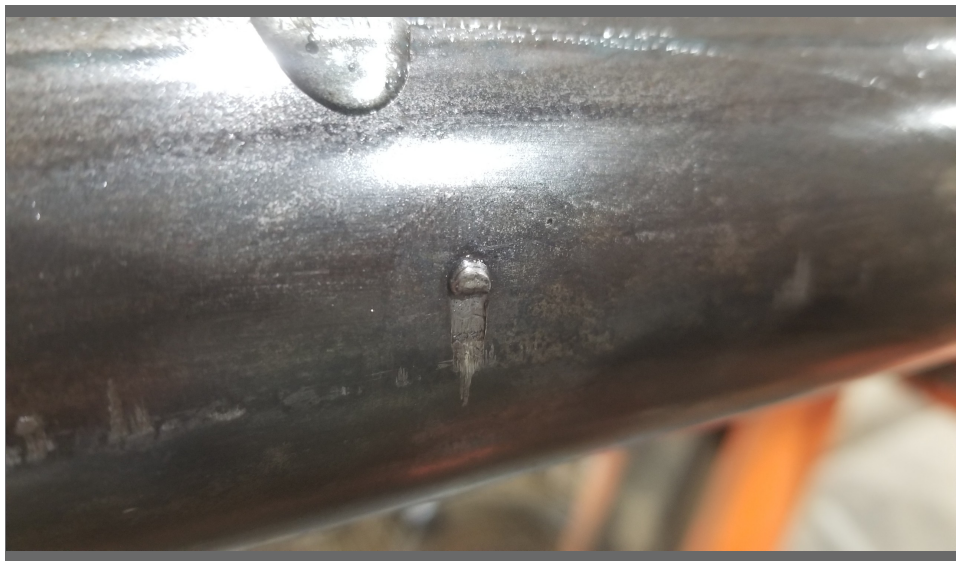
4,875m - 4,876m	OD (Max)	OD (Min)	Ovality	Pit Depth Gauge	UT (Max)	UT (Min)
Repaired	60.42mm (2.379")	59.88mm (2.357")	0.896%	0.018" or 0.457mm	4.50mm (0.177")	4.05mm (0.159")

External anomaly. Previous repair in area from manufacturer. This anomaly was repaired by Tenaris and measured before and after by CTI.

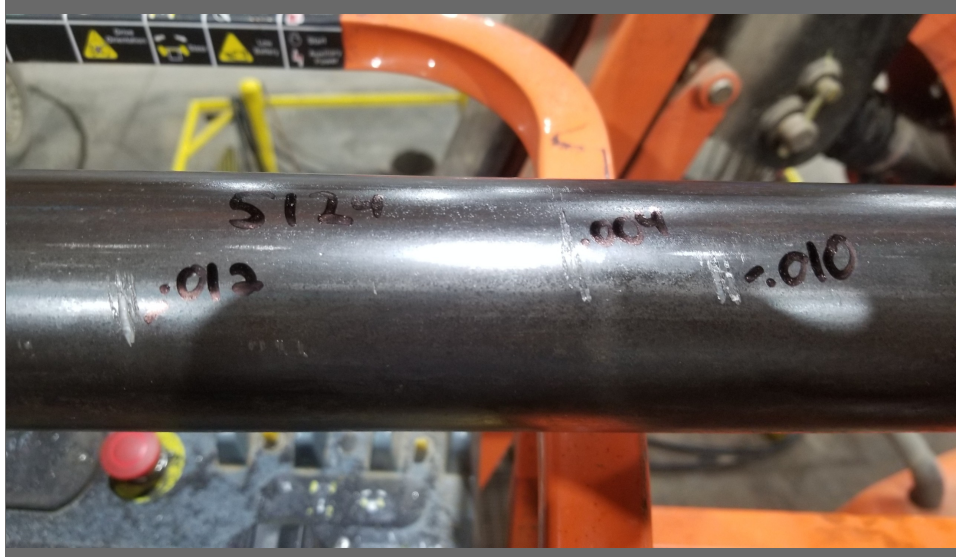
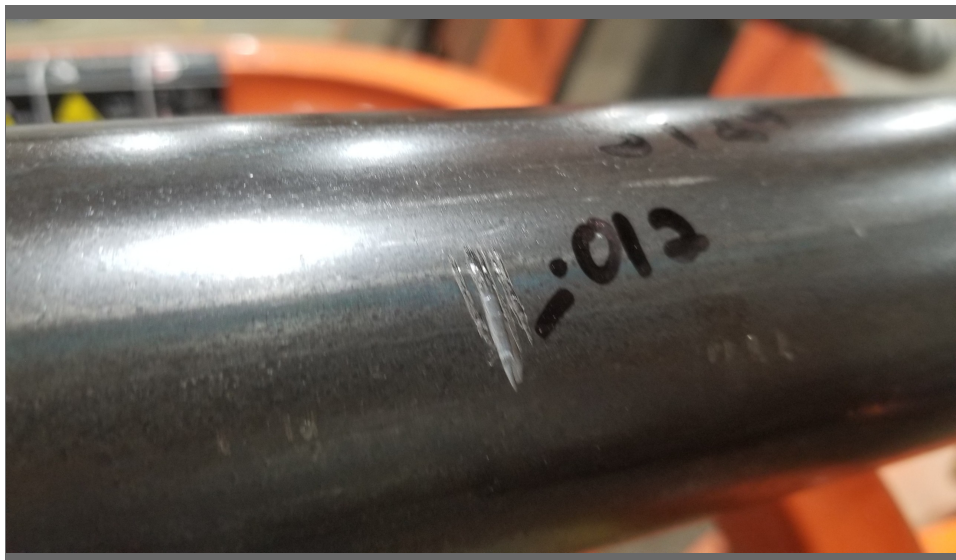
5,124m - 5,125m	OD (Max)	OD (Min)	Ovality	Pit Depth Gauge	UT (Max)	UT (Min)
Repaired	60.66mm (2.388")	60.33mm (2.375")	0.547%	0.012" or 0.305mm	4.52mm (0.178")	4.29mm (0.169")

Three external anomalies in area. These anomalies were repaired by Tenaris and measured before and after by CTI.

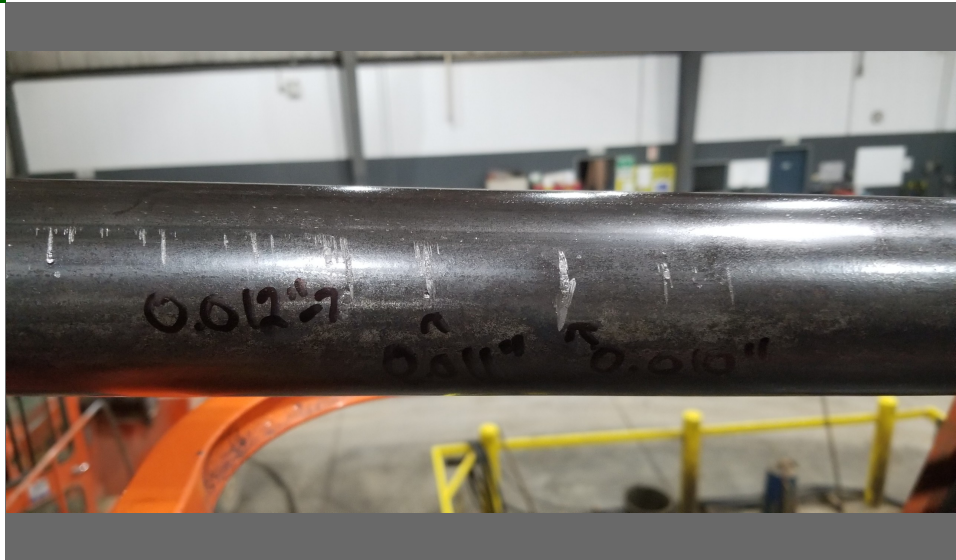
5,147m - 5,148m	OD (Max)	OD (Min)	Ovality	Pit gauge depth.	UT (Max)	UT (Min)
Repaired	60.51mm (2.382")	60.29mm (2.374")	0.365%	.012" or .305mm	4.59mm (0.181")	4.39mm (0.173")
External anomalies.

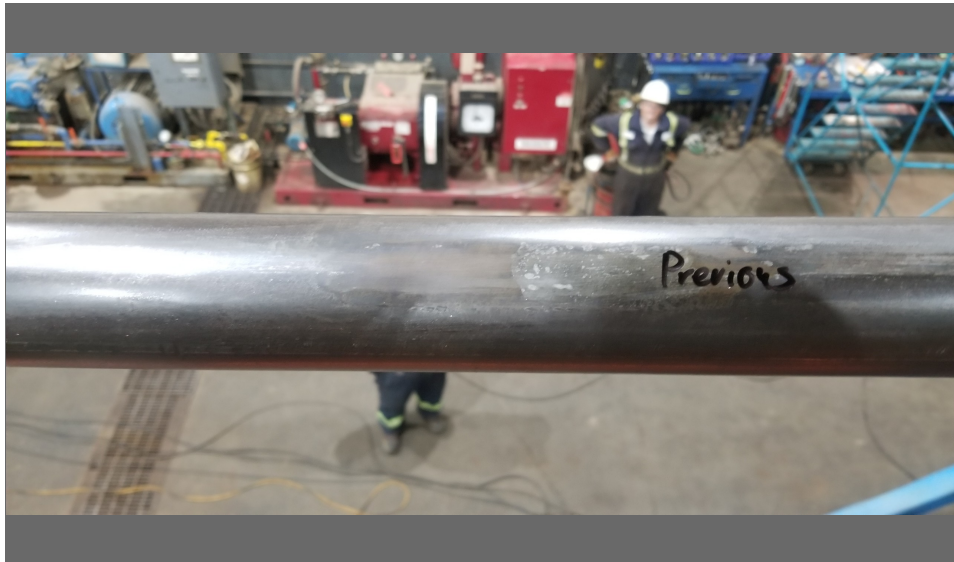
5,751m - 5,752m	OD (Max)	OD (Min)	Ovality	UT (Max)	UT (Min)
-----------------	----------	----------	---------	----------	----------

Previous repair from manufacturer indicated on CTI's tool. Low UT measurement of 12.4% metal loss from nominal.

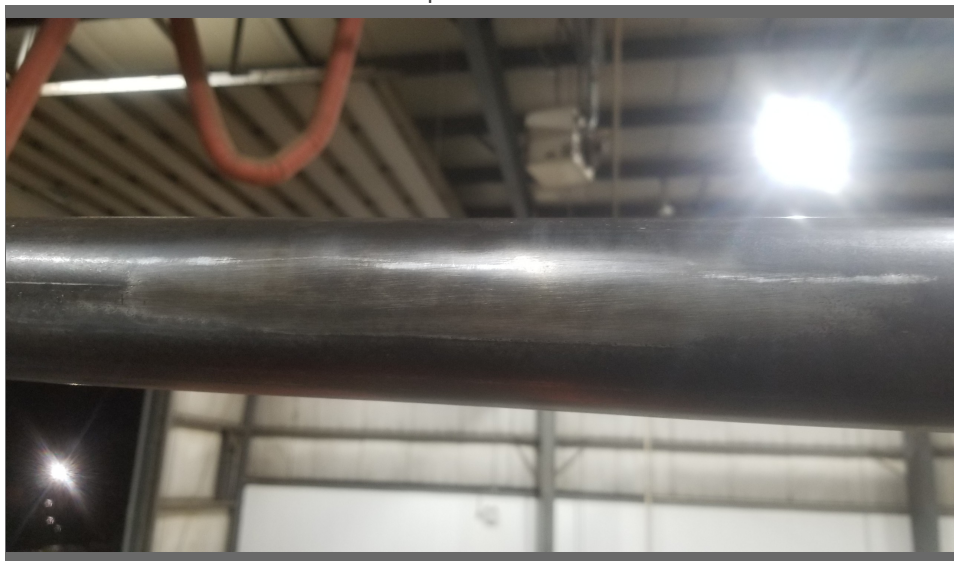
5,792m - 5,793m	OD (Max)	OD (Min)	Ovality	UT (Max)	UT (Min)
-----------------	----------	----------	---------	----------	----------

Previous repair by manufacturer indicated on CTI's tool. Low UT of 9.2% metal loss from nominal wall. Similar external repair from manufacturer at 5874m.

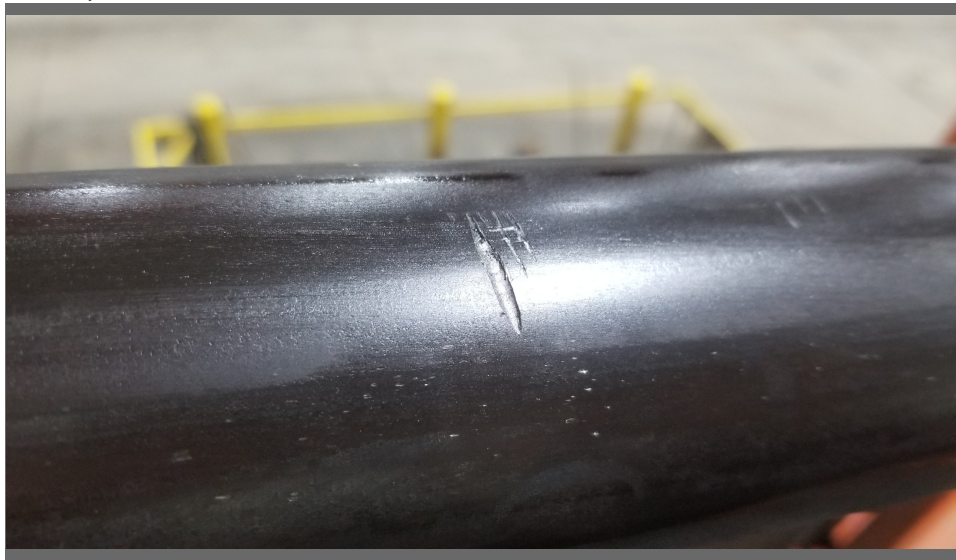
6,094m - 6,095m	OD (Max)	OD (Min)	Ovality	Pit Depth Gauge	UT (Max)	UT (Min)
Repaired	60.21mm (2.370")	59.93mm (2.359")	0.464%	0.014" or 0.356mm	4.57mm (0.180")	4.22mm (0.166")

External anomaly. This anomaly was repaired by Tenaris and measured before and after by CTI.
